**Flood Control Project Maintenance  
Levee Inspections**

## 2019 Channel Summary Report

## Merced Streams Group

**Levee Inspection Report By Mile - Channel 2019**

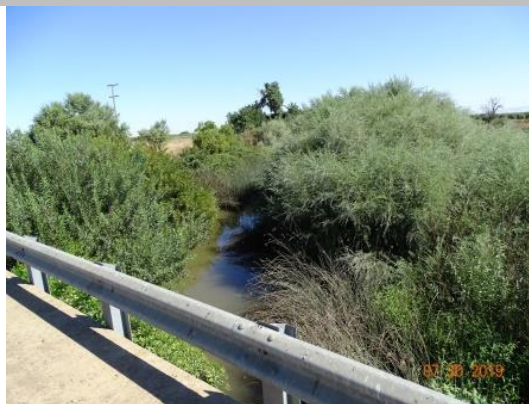
Photo 1 of 1 : CH\_2019\_NA0013\_32\_1\_20190807\_00063.jpg

Rating **	U	Issue No.	1	GPS Lat/Long
Issue Type +	Ma	Location *		37.336900 °
Category	Rivers, Channels & Designated Flood			-120.311100 °
Item	Vegetation & Obstructions			
DWR ID	DWR_NA0013_32_c_2016_1			
Action/Comments				
Inspector Comments: Vegetation in channel upstream of bridge crossing needs to be trimmed, as flow may be impeded.

View looking upstream at Bear Creek from Bonner Road Bridge Crossing. Summer 2019

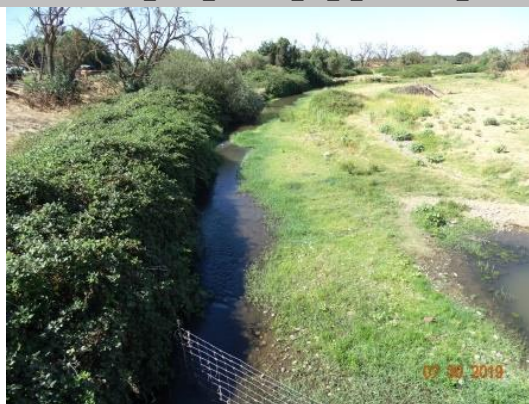
Photo 1 of 1 : CH\_2019\_NA0013\_32\_6\_20190807\_00064.jpg

Rating **	A	Issue No.	6	GPS Lat/Long
Issue Type +	Ma	Location *		37.336900 °
Category	Rivers, Channels & Designated Flood			-120.311100 °
Item	Vegetation & Obstructions			
DWR ID	DWR_NA0013_32_c_2016_6			
Action/Comments				
Inspector Comments: There is vegetation present downstream of bridge crossing, left bank; remove wild growth of berries.

View looking downstream at vegetation. Summer 2019

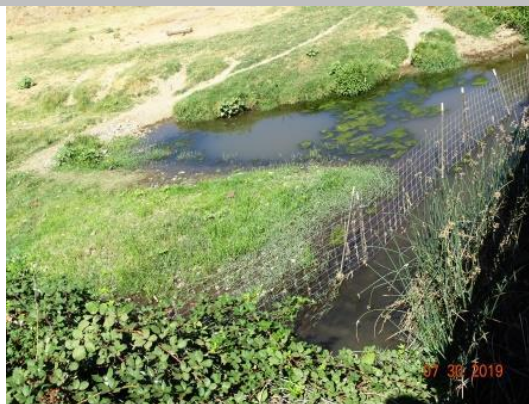
Photo 1 of 2 : CH\_2019\_NA0013\_32\_10\_20190807\_00065.jpg

Inspector Comments: The wire fence across the channel does not appear to have a permit and needs to be removed.

View of wire fence across channel. Summer 2019

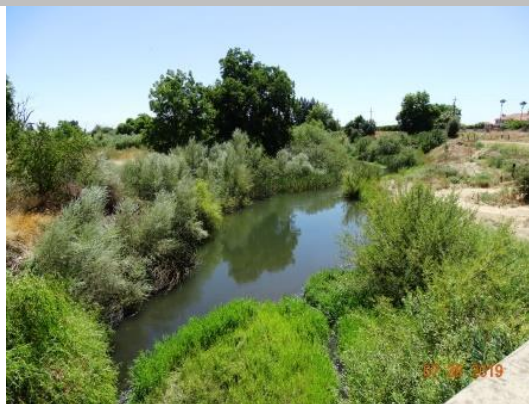
Photo 1 of 3 : CH\_2019\_NA0013\_32\_21\_20190808\_00066.jpg

Inspector Comments: There is growth in the channel and vegetation on both banks upstream of crossing. Recommend clearing vegetation at least 100ft upstream from the bridge.

View of vegetation looking upstream. Summer 2019

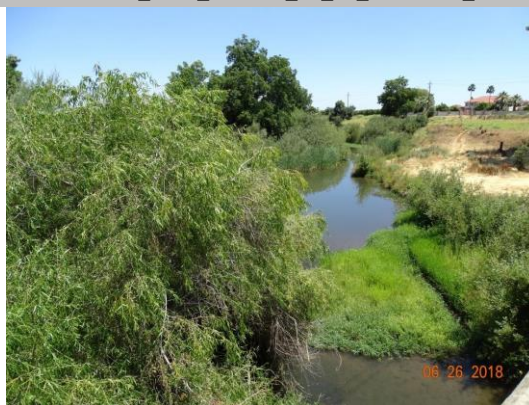
Photo 2 of 3 : CH\_2019\_NA0013\_32\_21\_20190722\_00007.jpg

Arboleda Drive crossing Bear Creek looking upstream. Summer 2018

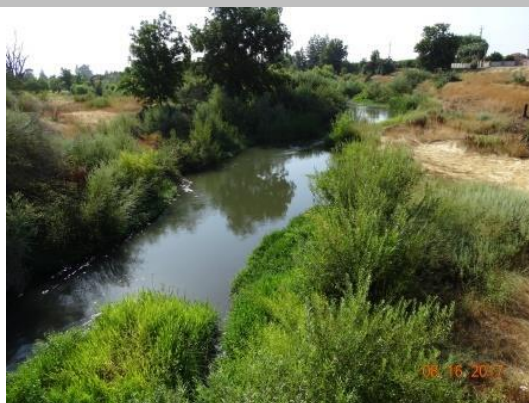
Photo 3 of 3 : CH\_2019\_NA0013\_32\_21\_20190722\_00009.jpg

Arboleda Drive crossing Bear Creek looking upstream.

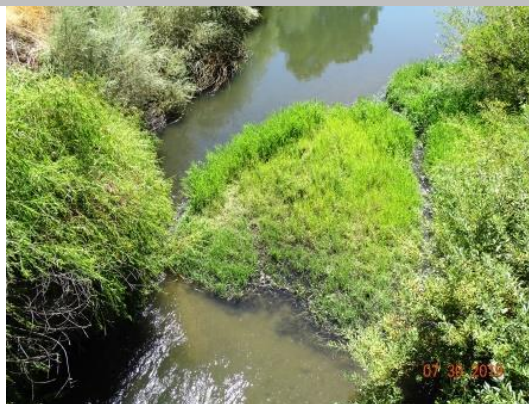
Photo 1 of 1 : CH\_2019\_NA0013\_32\_22\_20190808\_00067.jpg

Rating **	M	Issue No.	22	GPS Lat/Long
Issue Type +	Ma	Location *		37.310805 °
Category	Rivers, Channels & Designated Flood			-120.378733 °
Item	Shoaling / Sedimentation			
DWR ID	DWR_NA0013_32_c_2016_22			
Action/Comments				
Inspector Comments: There is shoaling with vegetation present in the channel.

There is shoaling with vegetation present in the channel. Summer 2019

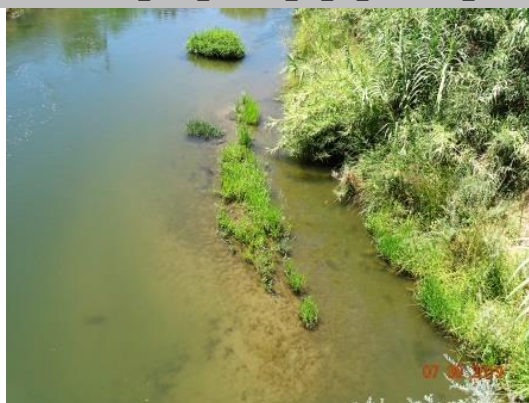
Photo 1 of 2 : CH\_2019\_NA0013\_32\_37\_20190808\_00072.jpg

Rating **	M	Issue No.	37	GPS Lat/Long
Issue Type +	Ma	Location *		37.312195 °
Category	Rivers, Channels & Designated Flood			-120.414967 °
Item	Shoaling / Sedimentation			
DWR ID	DWR_NA0013_32_c_2016_37			
Action/Comments				
Inspector Comments: There is shoaling downstream from the bridge crossing with grasses and brush growing on it.

View of shoaling with vegetation looking downstream. Summer 2019

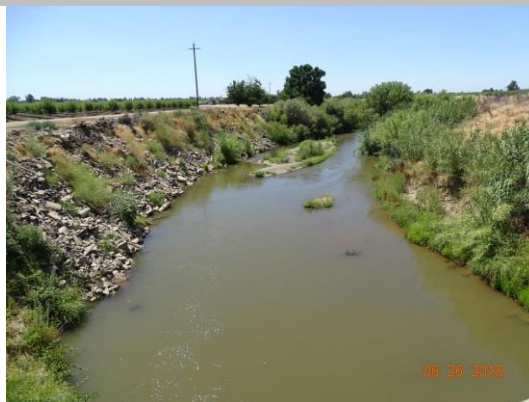
Photo 2 of 2 : CH\_2019\_NA0013\_32\_37\_20190722\_00020.jpg

Inspector Comments: There is shoaling downstream from the bridge crossing with grasses and brush growing on it.

Shoaling with vegetation present downstream from the bridge. Summer 2018

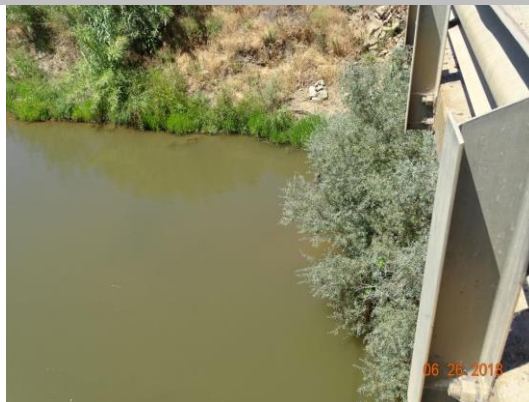
Photo 1 of 1 : CH\_2019\_NA0013\_32\_38\_20190722\_00022.jpg

Inspector Comments: There is some erosion on the right bank of the channel.

View of erosion on right bank of channel downstream of the bridge. Summer 2018

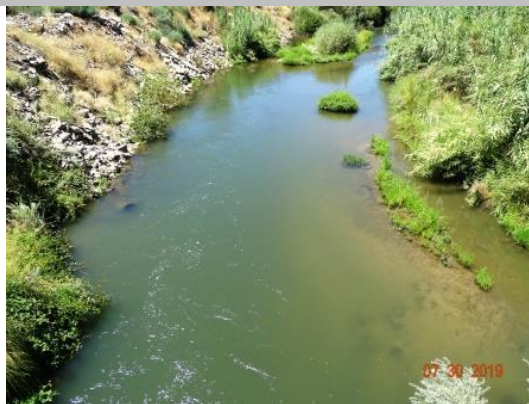
Photo 1 of 1 : CH\_2019\_NA0013\_32\_39\_20190808\_00073.jpg

Inspector Comments: There is riprap placed on the left bank slope downstream from the Kibby Road crossing.

View of riprap on the left bank. Summer 2019

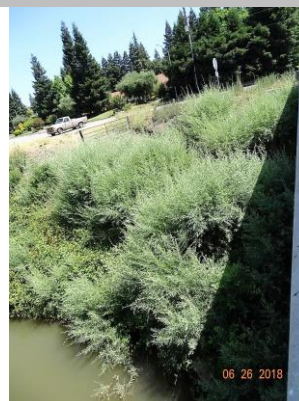
Photo 3 of 3 : CH\_2019\_NA0013\_32\_41\_20190722\_00026.jpg

Bear Creek upstream of McKee Rd crossing. Overgrown brush underneath crossing. Summer 2018

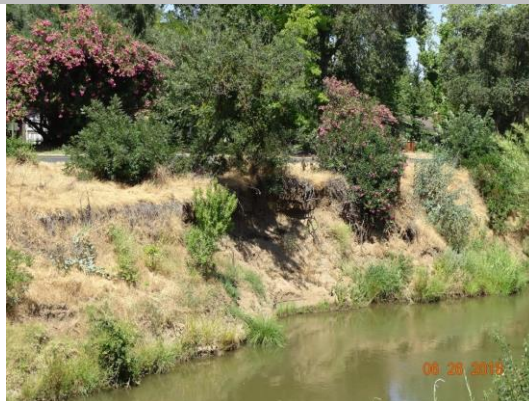
Photo 2 of 3 : CH\_2019\_NA0013\_32\_43\_20190722\_00028.jpg

View of erosion on the right bank upstream of McKee Rd bridge.  
Summer 2018

Inspector Comments: Erosion still present on the right bank upstream of the McKee Rd. Bank should be repaired before Flood Season.

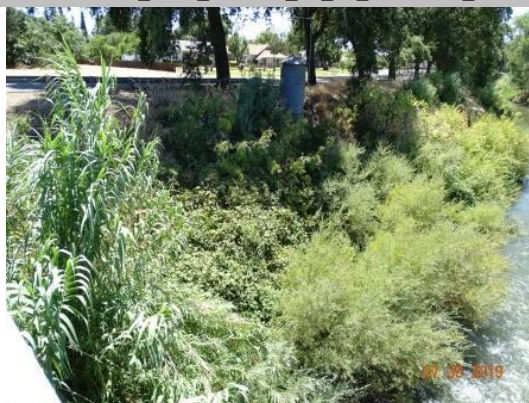
Photo 2 of 3 : CH\_2019\_NA0013\_32\_46\_20190808\_00077.jpg

View of Arundo at downstream side of the bridge. Summer 2019

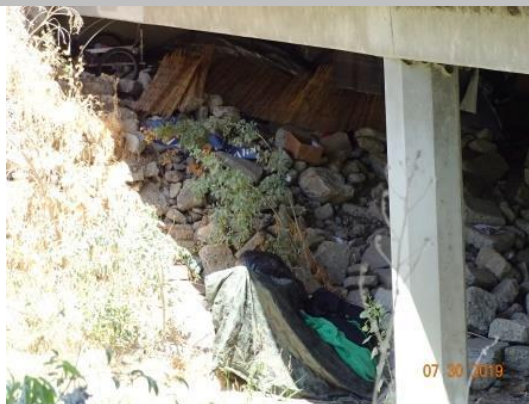
Photo 1 of 1 : CH\_2019\_NA0013\_32\_50\_20190814\_00094.jpg

Inspector Comments: Remove homeless debris on right bank underneath bridge.

View of homeless debris on the right bank. Summer 2019

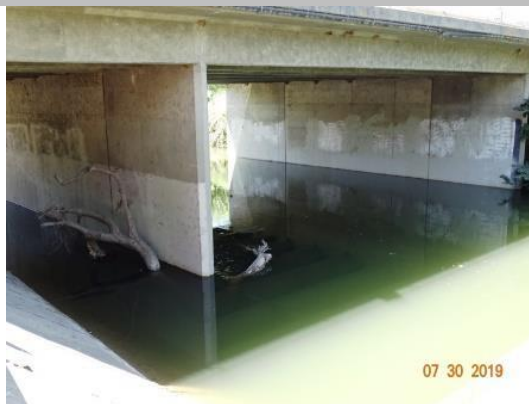
Photo 1 of 1 : CH\_2019\_NA0013\_32\_55\_20190808\_00080.jpg

Inspector Comments: Tree debris remain on upstream side of bridge pier.

View of tree debris on upstream side of bridge pier. Summer 2019

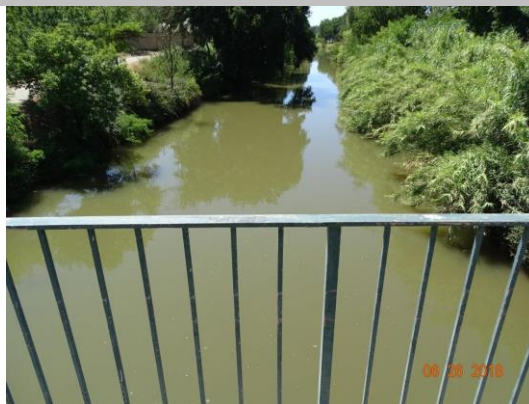
Photo 1 of 2 : CH\_2019\_NA0013\_32\_56\_20190722\_00039.jpg

Inspector Comments: The arundo on the right bank needs to be removed.

Bear Creek looking downstream from R street bridge crossing. Summer 2018

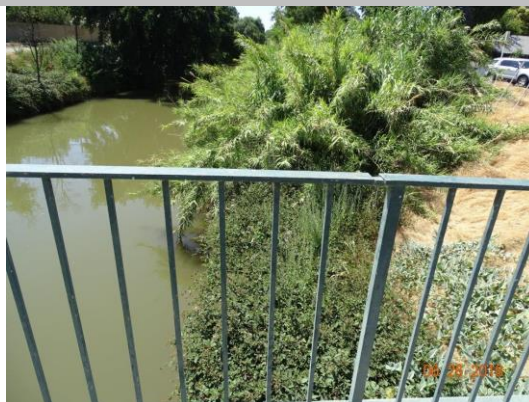
Photo 2 of 2 : CH\_2019\_NA0013\_32\_56\_20190722\_00040.jpg

Rating **	A	Issue No.	56 (cont)	GPS Lat/Long
Issue Type +	Ma	Location *		37.313400 °
Category	Rivers, Channels & Designated Flood			-120.487500 °
Item	Vegetation & Obstructions			
DWR ID	DWR_NA0013_32_c_2016_56			
Action/Comments				
Inspector Comments: The arundo on the right bank needs to be removed.

Bear Creek looking downstream from R street bridge crossing. Summer 2018

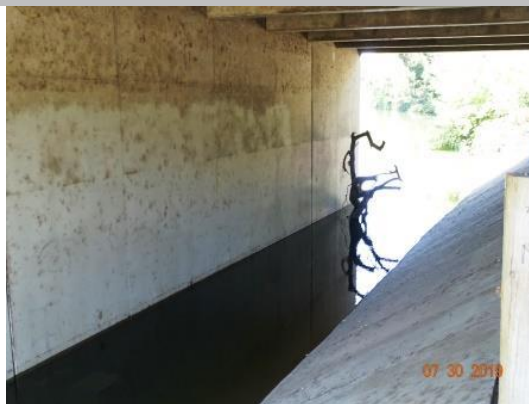
Photo 1 of 1 : CH\_2019\_NA0013\_32\_59\_20190808\_00081.jpg

Rating **	A	Issue No.	59	GPS Lat/Long
Issue Type +	Ma	Location *		37.313400 °
Category	Rivers, Channels & Designated Flood			-120.487500 °
Item	Revetments			
DWR ID	DWR_NA0013_32_c_2016_59			
Action/Comments				
Inspector Comments: The banks are concrete lined at the bridge crossing.

View looking upstream at concrete-lined banks underneath bridge.  
Summer 2019

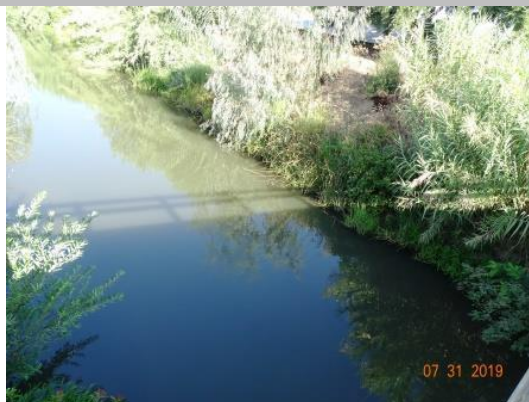
Photo 1 of 2 : CH\_2019\_NA0013\_32\_66\_20190808\_00085.jpg

Inspector Comments: Remove Arundo on right bank.

View looking downstream from Franklin Road crossing. Summer 2019

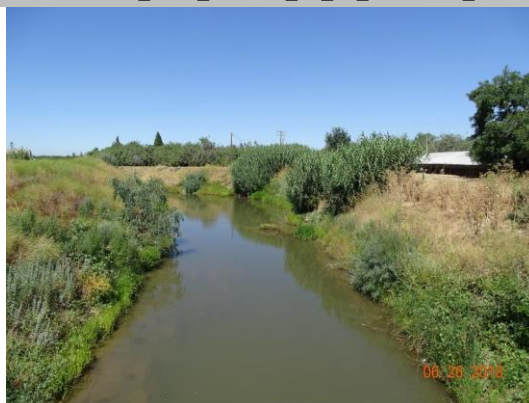
Photo 2 of 2 : CH\_2019\_NA0013\_32\_66\_20190722\_00045.jpg

Bear Creek looking downstream from Franklin Road crossing. Summer 2018

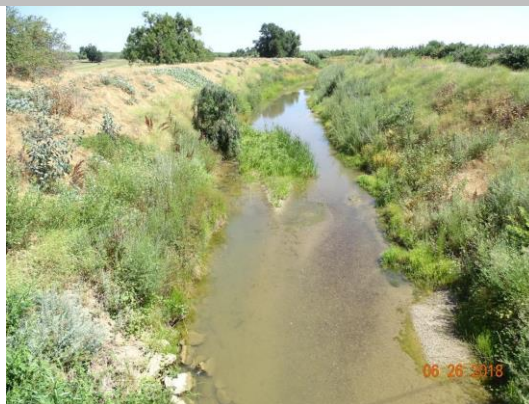
Photo 1 of 1 : CH\_2019\_NA0013\_32\_72\_20190722\_00049.jpg

Rating **	M	Issue No.	72	GPS Lat/Long
Issue Type +	Ma	Location *		37.302576 °
Category	Rivers, Channels & Designated Flood			-120.551477 °
Item	Shoaling / Sedimentation			
DWR ID	DWR_NA0013_32_c_2016_72			
Action/Comments				
Inspector Comments: Shoaling is present in channel at this location with vegetation growth established.

Shoaling and sedimentation present in channel upstream of Hwy 140 crossing. Summer 2018

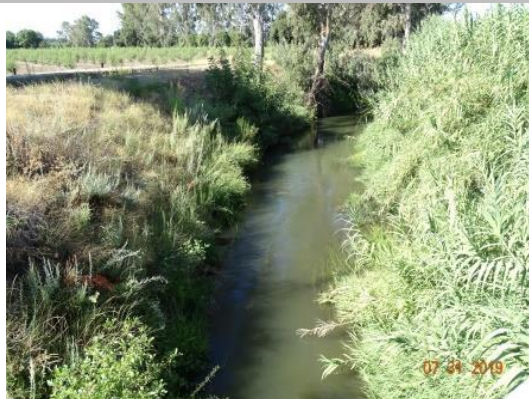
Photo 1 of 2 : CH\_2019\_NA0013\_32\_76\_20190808\_00083.jpg

Check Point / View				
Hwy 140 / Down				
Rating **	M	Issue No.	76	GPS Lat/Long
Issue Type +	Ma	Location *		37.302576 °
Category	Rivers, Channels & Designated Flood			-120.551477 °
Item	Vegetation & Obstructions			
DWR ID	DWR_NA0013_32_c_2018_76			
Action/Comments				
Inspector Comments: Wild growth in the channel downstream of and underneath bridge should be controlled. Remove Arundo.

View looking downstream from Hwy 140 bridge crossing. Summer 2019

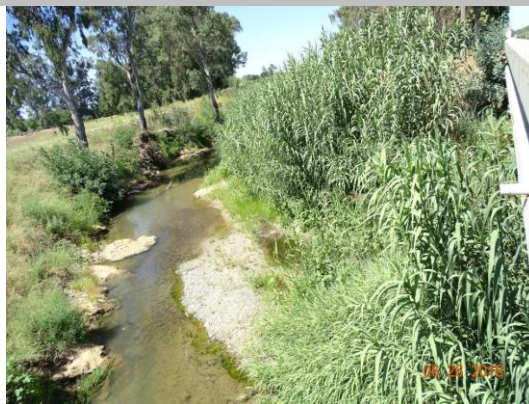
Photo 2 of 2 : CH\_2019\_NA0013\_32\_76\_20190722\_00050.jpg

Rating **	M	Issue No.	76 (cont)	GPS Lat/Long
Issue Type +	Ma	Location *		37.302576 °
Category	Rivers, Channels & Designated Flood			-120.551477 °
Item	Vegetation & Obstructions			
DWR ID	DWR_NA0013_32_c_2018_76			
Action/Comments				
Inspector Comments: Wild growth in the channel downstream of and underneath bridge should be controlled. Remove Arundo.

Bear Creek looking downstream from Hwy 140 bridge crossing.  
Summer 2018

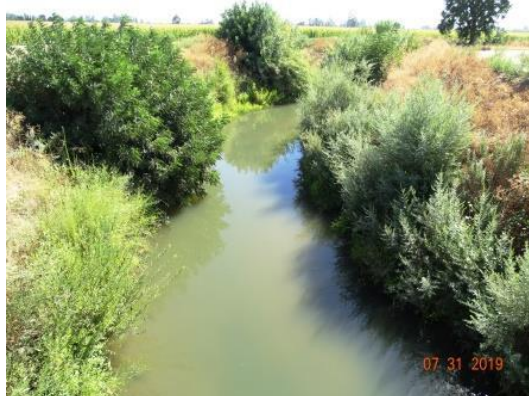
Photo 1 of 2 : CH\_2019\_NA0013\_32\_81\_20190808\_00086.jpg

Rating **	A	Issue No.	81	GPS Lat/Long
Issue Type +	Ma	Location *		37.291282 °
Category	Rivers, Channels & Designated Flood			-120.577961 °
Item	Vegetation & Obstructions			
DWR ID	DWR_NA0013_32_c_2016_81			
Action/Comments				
Inspector Comments: Remove Arundo on the left bank.

View of Bear Creek looking upstream from Buhach Road crossing.  
Summer 2019

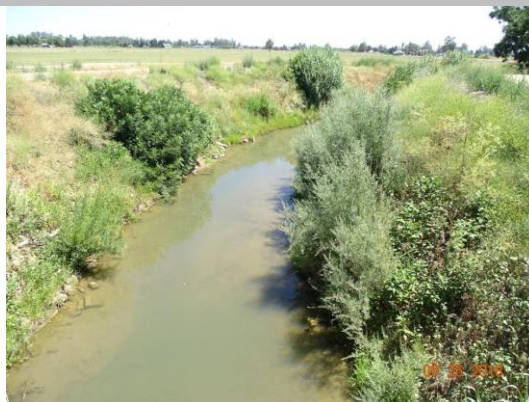
Photo 2 of 2 : CH\_2019\_NA0013\_32\_81\_20190722\_00053.jpg

Rating **	A	Issue No.	81 (cont)	GPS Lat/Long
Issue Type +	Ma	Location *		37.291282 °
Category	Rivers, Channels & Designated Flood			-120.577961 °
Item	Vegetation & Obstructions			
DWR ID	DWR_NA0013_32_c_2016_81			
Action/Comments				
Inspector Comments: Remove Arundo on the left bank.

Bear Creek looking upstream from Buhach Road crossing. Summer 2018

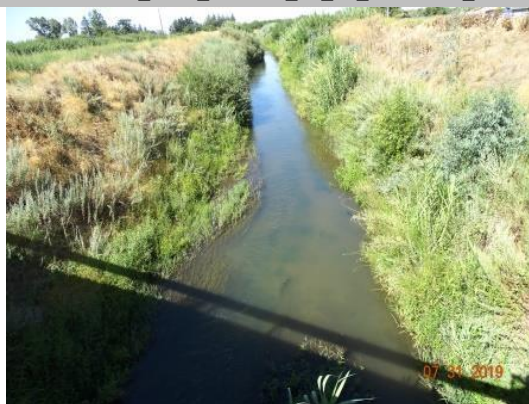
Photo 1 of 2 : CH\_2019\_NA0013\_32\_86\_20190808\_00087.jpg

Rating **	A	Issue No.	86	GPS Lat/Long
Issue Type +	Ma	Location *		37.291282 °
Category	Rivers, Channels & Designated Flood			-120.577961 °
Item	Vegetation & Obstructions			
DWR ID	DWR_NA0013_32_c_2016_86			
Action/Comments				
Inspector Comments: Remove Arundo underneath the bridge.

View of Bear Creek looking downstream from Buhach Road crossing.  
Summer 2019

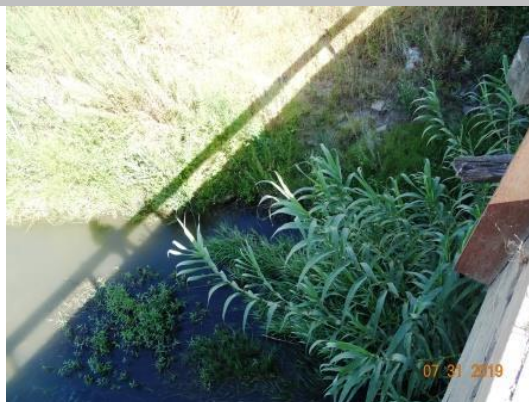
Photo 2 of 2 : CH\_2019\_NA0013\_32\_86\_20190808\_00088.jpg

Rating **	A	Issue No.	86 (cont)	GPS Lat/Long
Issue Type +	Ma	Location *		37.291282 °
Category	Rivers, Channels & Designated Flood			-120.577961 °
Item	Vegetation & Obstructions			
DWR ID	DWR_NA0013_32_c_2016_86			
Action/Comments				
Inspector Comments: Remove Arundo underneath the bridge.

View of Arundo at Buhach Road crossing. Summer 2019

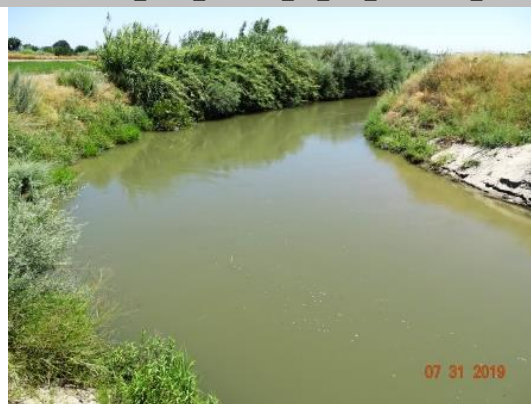
Photo 1 of 2 : CH\_2019\_NA0013\_32\_101\_20190809\_00089.jpg

Rating **	A	Issue No.	101	GPS Lat/Long
Issue Type +	Ma	Location *		37.256440 °
Category	Rivers, Channels & Designated Flood			-120.651870 °
Item	Vegetation & Obstructions			
DWR ID	DWR_NA0013_32_c_2016_101			
Action/Comments				
Inspector Comments: Remove Arundo on right bank.

View of Bear Creek looking upstream from Bert Crane Rd. crossing.  
Summer 2019

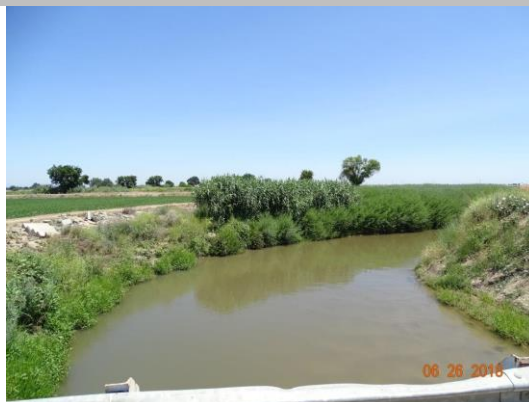
Photo 2 of 2 : CH\_2019\_NA0013\_32\_101\_20190722\_00057.jpg

Rating **	A	Issue No.	101 (cont)	GPS Lat/Long
Issue Type +	Ma	Location *		37.256440 °
Category	Rivers, Channels & Designated Flood			-120.651870 °
Item	Vegetation & Obstructions			
DWR ID	DWR_NA0013_32_c_2016_101			
Action/Comments				
Inspector Comments: Remove Arundo on right bank.

Bear Creek looking upstream from Bert Crane Rd. crossing. Summer 2018

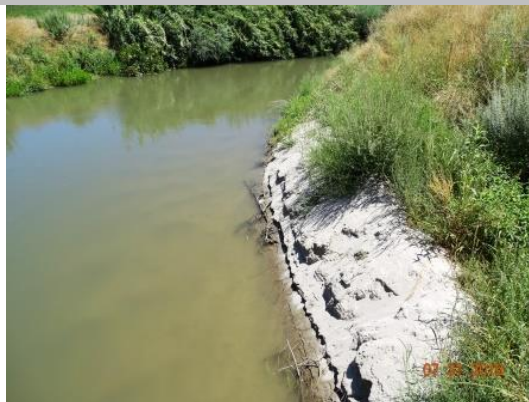
Photo 1 of 1 : CH\_2019\_NA0013\_32\_102\_20190809\_00090.jpg

Rating **	M	Issue No.	102	GPS Lat/Long
Issue Type +	Ma	Location *		37.256440 °
Category	Rivers, Channels & Designated Flood			-120.651870 °
Item	Shoaling / Sedimentation			
DWR ID	DWR_NA0013_32_c_2016_102			
Action/Comments				
Inspector Comments: There is sedimentation on the left bank, but channel flow does not appear to be impeded.

View of sedimentation along left bank. Summer 2019

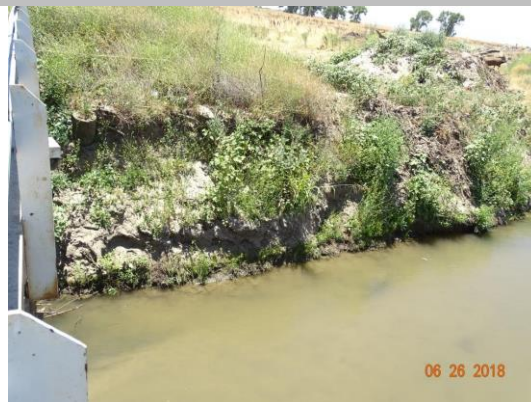
Photo 2 of 2 : CH\_2019\_NA0013\_32\_108\_20190722\_00061.jpg

Inspector Comments: Erosion on the left bank is mitigated with a wooden retaining wall, and the channel capacity does not appear to be affected.

View of erosion on left bank downstream of the Bert Crane Rd crossing.  
Summer 2018

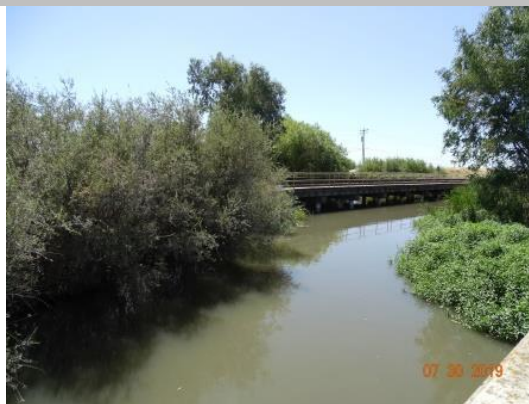
Photo 1 of 1 : CH\_2019\_NA0013\_33\_6\_20190808\_00052.jpg

Inspector Comments: There is vegetation in the channel, but it does not appear to impede the capacity of the channel at this time.

View of vegetation looking downstream. Summer 2019

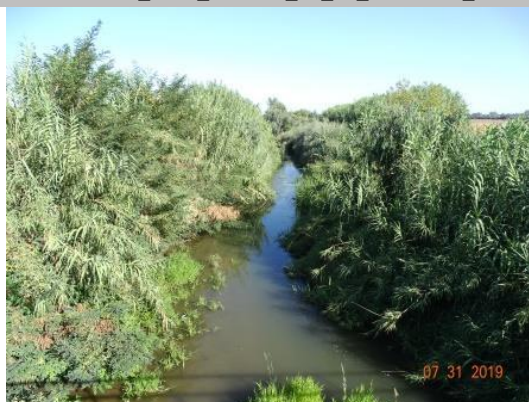
Photo 1 of 2 : CH\_2019\_NA0013\_33\_16\_20190808\_00058.jpg

Rating **	M	Issue No.	16	GPS Lat/Long
Issue Type +	Ma	Location *		37.312458 °
Category	Rivers, Channels & Designated Flood			-120.532708 °
Item	Vegetation & Obstructions			
DWR ID	DWR_NA0013_33_c_2016_16			
Action/Comments				
Inspector Comments: Remove Arundo wild growth from both banks.

View of vegetation and Arundo on both banks. Summer 2019

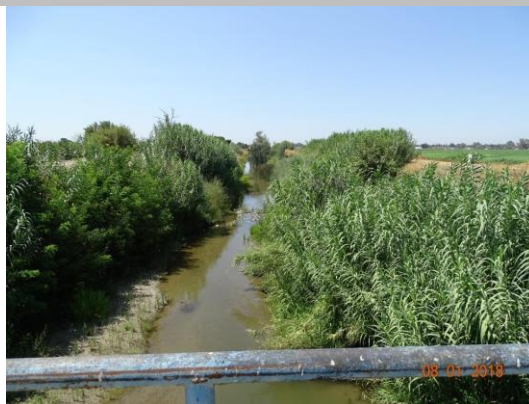
Photo 2 of 2 : CH\_2019\_NA0013\_33\_16\_20190722\_00006.jpg

Rating **	M	Issue No.	16 (cont)	GPS Lat/Long
Issue Type +	Ma	Location *		37.312458 °
Category	Rivers, Channels & Designated Flood			-120.532708 °
Item	Vegetation & Obstructions			
DWR ID	DWR_NA0013_33_c_2016_16			
Action/Comments				
Inspector Comments: Remove Arundo wild growth from both banks.

View of Arundo along right bank. Summer 2018

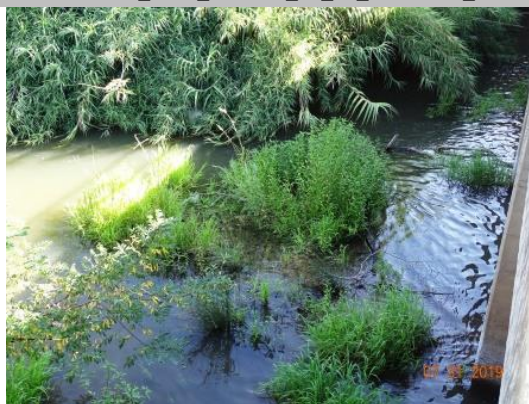
Photo 1 of 2 : CH\_2019\_NA0013\_33\_17\_20190808\_00059.jpg

View of shoaling with vegetation downstream of dam. Summer 2019

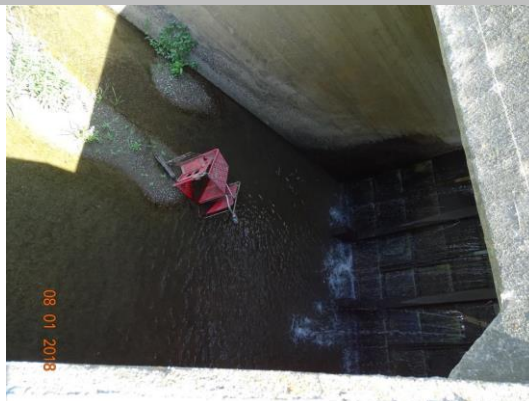
Photo 1 of 1 : CH\_2019\_NA0013\_33\_20\_20190722\_00011.jpg

View of a grocery cart in the channel. Summer 2018

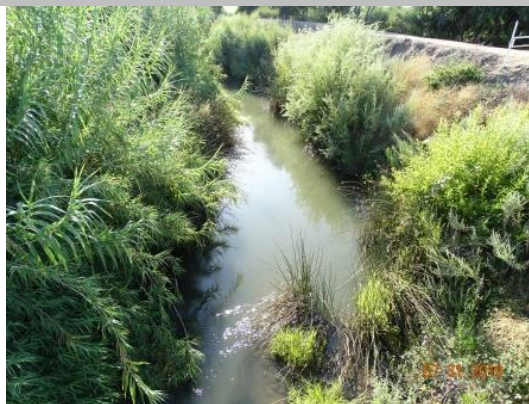
Photo 1 of 1 : CH\_2019\_NA0013\_33\_21\_20190808\_00053.jpg

Rating **	M	Issue No.	21	GPS Lat/Long
Issue Type +	Ma	Location *		37.314050 °
Category	Rivers, Channels & Designated Flood			-120.541078 °
Item	Vegetation & Obstructions			
DWR ID	DWR_NA0013_33_c_2016_21			
Action/Comments				
Inspector Comments: Remove Arundo from right bank.

View of vegetation looking upstream. Summer 2019

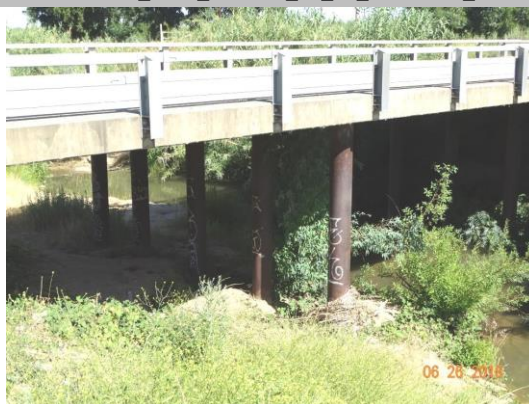
Photo 1 of 1 : CH\_2019\_NA0013\_33\_22\_20190722\_00015.jpg

Rating **	M	Issue No.	22	GPS Lat/Long
Issue Type +	Ma	Location *		37.314050 °
Category	Rivers, Channels & Designated Flood			-120.541078 °
Item	Shoaling / Sedimentation			
DWR ID	DWR_NA0013_33_c_2016_22			
Action/Comments				
Inspector Comments: There is shoaling with brush underneath the crossing, but flow does not appear to be impeded.

Shoaling with vegetation present upstream of and underneath Franklin Road crossing. Summer 2018

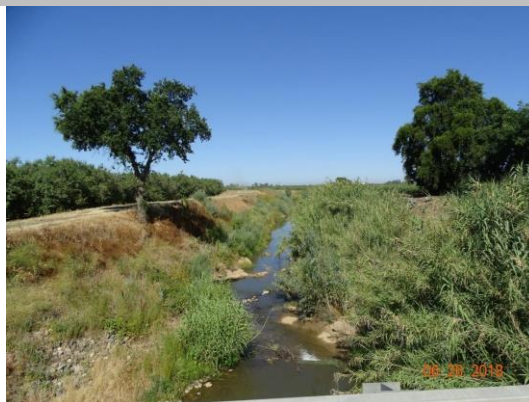
Photo 2 of 3 : CH\_2019\_NA0013\_33\_26\_20190722\_00016.jpg

Rating **	M	Issue No.	26 (cont)	GPS Lat/Long
Issue Type +	Ma	Location *		37.314050 °
Category	Rivers, Channels & Designated Flood			-120.541078 °
Item	Vegetation & Obstructions			
DWR ID	DWR_NA0013_33_c_2016_26			
Action/Comments				
Inspector Comments: Remove Arundo growth.

Black Rascal Creek looking downstream from Franklin Road crossing.  
Summer 2018

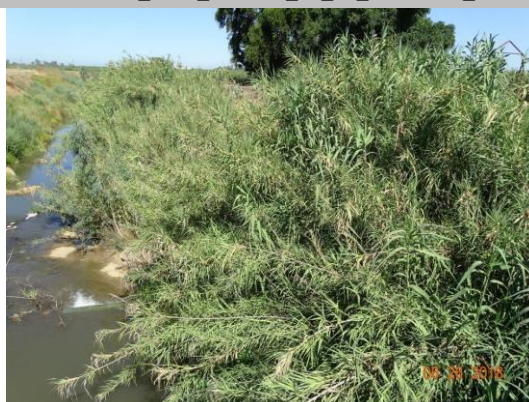
Photo 3 of 3 : CH\_2019\_NA0013\_33\_26\_20190722\_00017.jpg

Black Rascal Creek looking downstream from Franklin Road crossing.  
Summer 2018

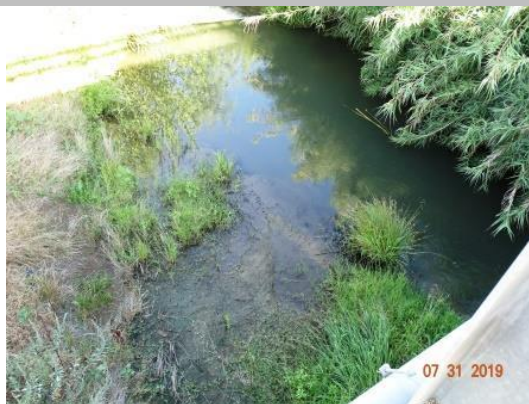
Photo 1 of 2 : CH\_2019\_NA0013\_33\_27\_20190808\_00055.jpg

Inspector Comments: Shoaling with brush exists, but flow does not appear to be impeded.

View of shoaling downstream of the bridge. Summer 2019

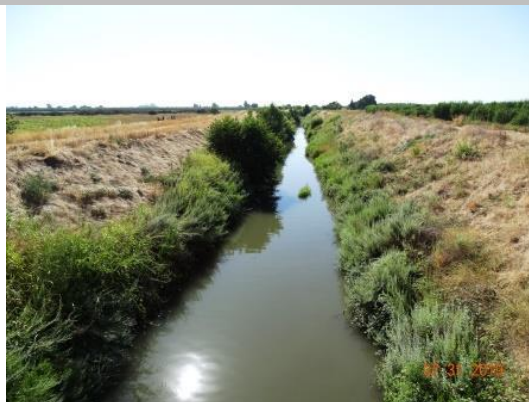
Photo 1 of 1 : CH\_2019\_NA0013\_33\_31\_20190808\_00062.jpg

Rating **	A	Issue No.	31	GPS Lat/Long
Issue Type +	Ma	Location *		37.313110 °
Category	Rivers, Channels & Designated Flood			-120.559070 °
Item	Vegetation & Obstructions			
DWR ID	DWR_NA0013_33_c_2016_31			
Action/Comments				
Inspector Comments: Brush underneath the crossing needs to be controlled, but vegetation does not appear to impede flow.

View of vegetation upstream of Gurr Road. Summer 2019

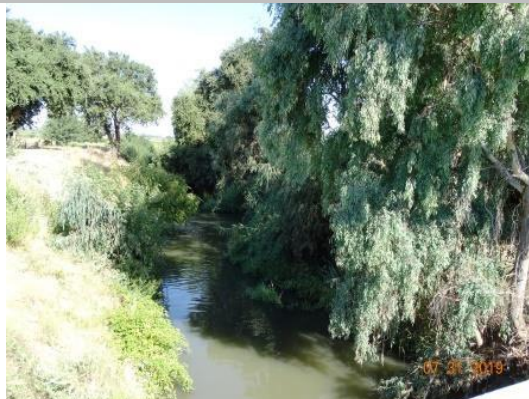
Photo 1 of 1 : CH\_2019\_NA0013\_33\_36\_20190808\_00063.jpg

Check Point / View				
Gurr Rd / Down				
Rating **	U	Issue No.	36	GPS Lat/Long
Issue Type +	Ma	Location *		37.313110 °
Category	Rivers, Channels & Designated Flood			-120.559070 °
Item	Vegetation & Obstructions			
DWR ID	DWR_NA0013_33_c_2016_36			
Action/Comments				
Inspector Comments: The wild growth on the right bank needs to be removed as its extending into the channel making it hard to inspect.

View looking downstream from Gurr Road crossing. Summer 2019

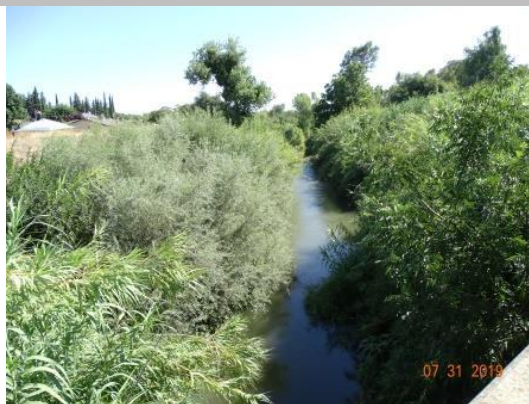
Photo 1 of 2 : CH\_2019\_NA0013\_33\_41\_20190808\_00061.jpg

Inspector Comments: Arundo is taking over the channel and should be removed.

View of vegetation upstream of Hwy 140. Summer 2019

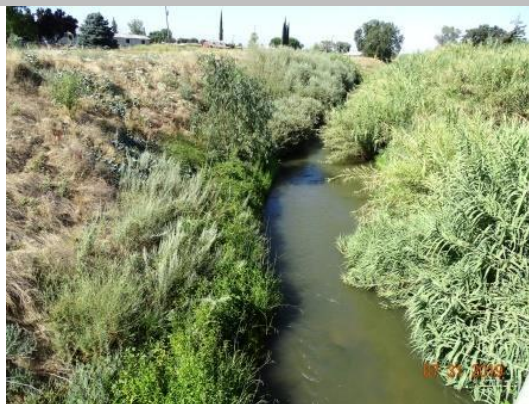
Photo 1 of 2 : CH\_2019\_NA0013\_33\_46\_20190808\_00060.jpg

Rating **	M	Issue No.	46	GPS Lat/Long
Issue Type +	Ma	Location *		37.302329 °
Category	Rivers, Channels & Designated Flood			-120.575613 °
Item	Vegetation & Obstructions			
DWR ID	DWR_NA0013_33_c_2016_46			
Action/Comments				
Inspector Comments: Remove wild Arundo growth.

View of vegetation downstream of Hwy 140. Summer 2019

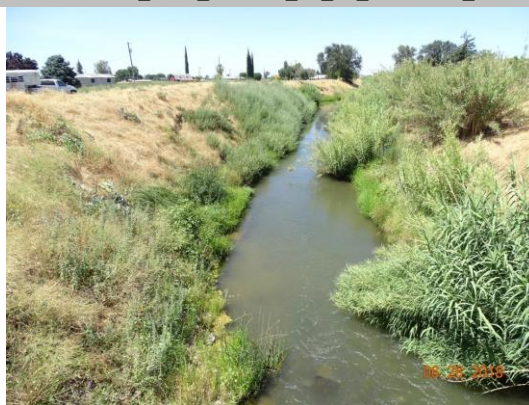
Photo 2 of 2 : CH\_2019\_NA0013\_33\_46\_20190722\_00029.jpg

Black Rascal Creek looking downstream from Hwy 140 crossing.  
Summer 2018

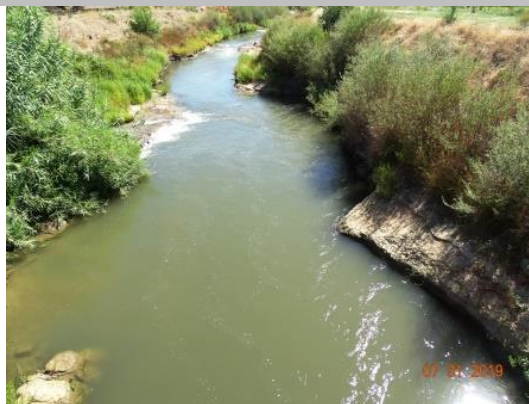
Photo 1 of 2 : CH\_2019\_NA0013\_33\_51\_20190809\_00064.jpg

Rating **	A	Issue No.	51	GPS Lat/Long
Issue Type +	Ma	Location *		37.293797 °
Category	Rivers, Channels & Designated Flood			-120.596922 °
Item	Vegetation & Obstructions			
DWR ID	DWR_NA0013_33_c_2016_51			
Action/Comments				
Inspector Comments: Remove Arundo on right bank.

View of Black Rascal Creek upstream of Quinley Road crossing.  
Summer 2019

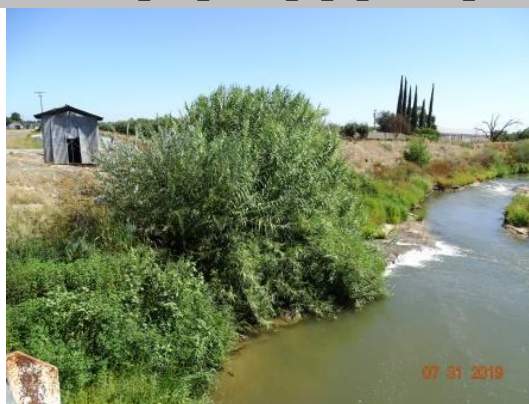
Photo 2 of 2 : CH\_2019\_NA0013\_33\_51\_20190809\_00065.jpg

View of Black Rascal Creek upstream of Quinley Road crossing.  
Summer 2019

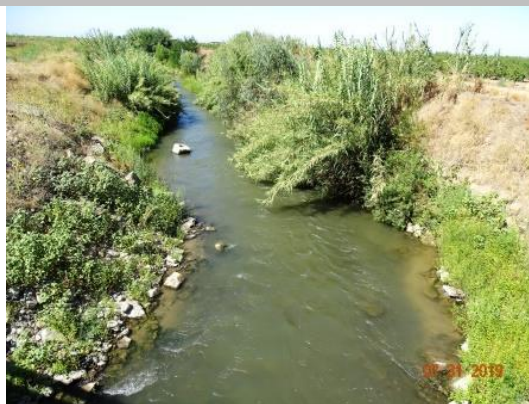
Photo 1 of 2 : CH\_2019\_NA0013\_33\_56\_20190809\_00067.jpg

Rating **	M	Issue No.	56	GPS Lat/Long
Issue Type +	Ma	Location *		37.293797 °
Category	Rivers, Channels & Designated Flood			-120.596922 °
Item	Vegetation & Obstructions			
DWR ID	DWR_NA0013_33_c_2016_56			
Action/Comments				
Inspector Comments: Remove Arundo from both banks.

View of vegetation downstream. Summer 2019

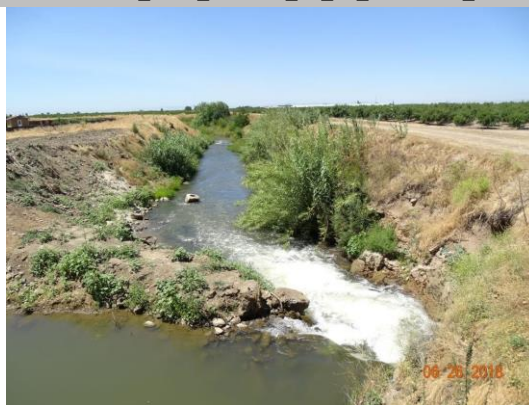
Photo 2 of 2 : CH\_2019\_NA0013\_33\_56\_20190722\_00034.jpg

View of Black Rascal Creek from Quinley Rd. crossing looking downstream. Summer 2018

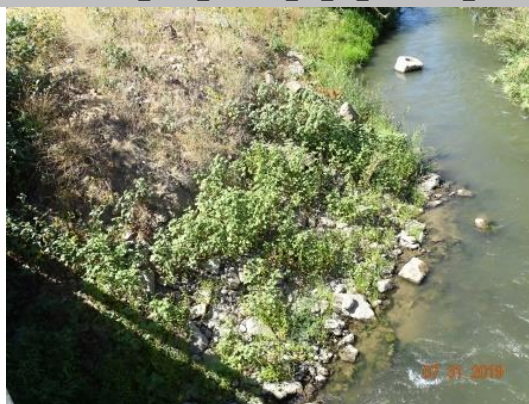
Photo 1 of 2 : CH\_2019\_NA0013\_33\_60\_20190813\_00077.jpg

Rating **	A	Issue No.	60	GPS Lat/Long
Issue Type +	En	Location *		37.293797 °
Category	Rivers, Channels & Designated Flood			-120.596922 °
Item	Encroachments			
DWR ID	DWR_NA0013_33_c_2016_60			
Action/Comments				
Inspector Comments: Landowner has removed the rock dam.

View of channel with dam removed. Summer 2019

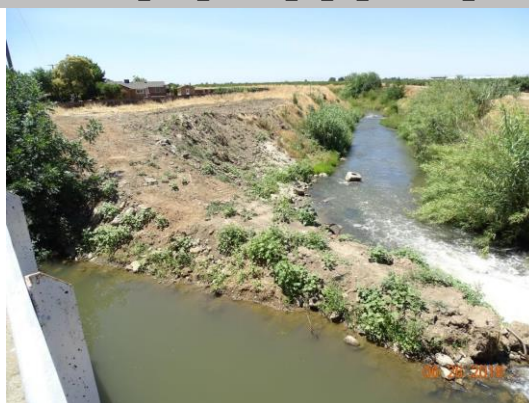
Photo 2 of 2 : CH\_2019\_NA0013\_33\_60\_20190722\_00037.jpg

Black Rascal Creek looking downstream from Quinley Rd. crossing.  
Rock dam remains in channel. Summer 2018

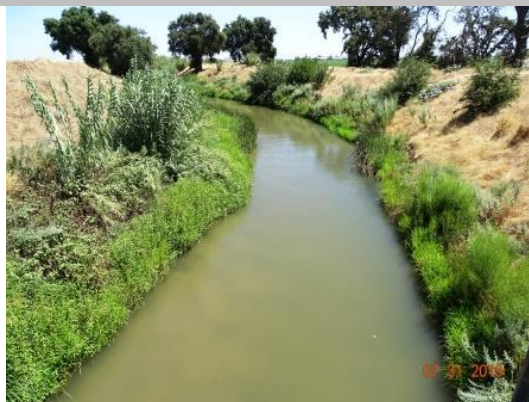
Photo 1 of 2 : CH\_2019\_NA0013\_33\_61\_20190809\_00071.jpg

Black Rascal Creek from Oak Avenue crossing. Summer 2019

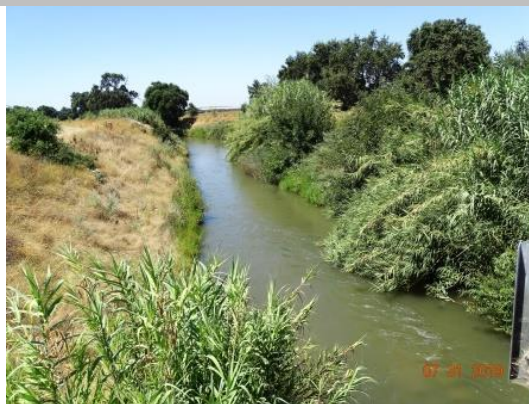
Photo 1 of 2 : CH\_2019\_NA0013\_33\_66\_20190809\_00073.jpg

Rating **	A	Issue No.	66	GPS Lat/Long
Issue Type +	Ma	Location *		37.280330 °
Category	Rivers, Channels & Designated Flood			-120.609400 °
Item	Vegetation & Obstructions			
DWR ID	DWR_NA0013_33_c_2018_66			
Action/Comments				
Inspector Comments: Arundo underneath crossing should be removed, but the vegetation does not appear to impede flow.

Black Rascal Creek looking downstream from Oak Avenue crossing.  
Overgrown brush underneath crossing. Summer 2019

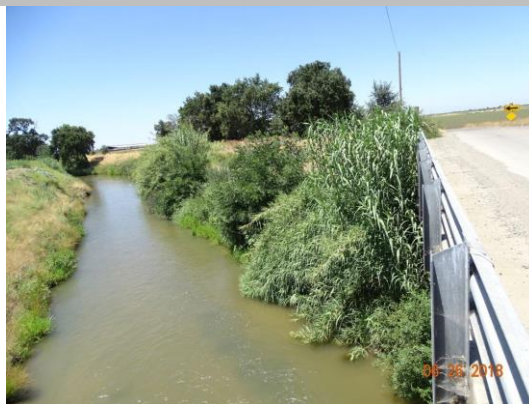
Photo 2 of 2 : CH\_2019\_NA0013\_33\_66\_20190722\_00043.jpg

Black Rascal Creek looking downstream from Oak Avenue crossing.  
Overgrown brush underneath crossing. Summer 2018

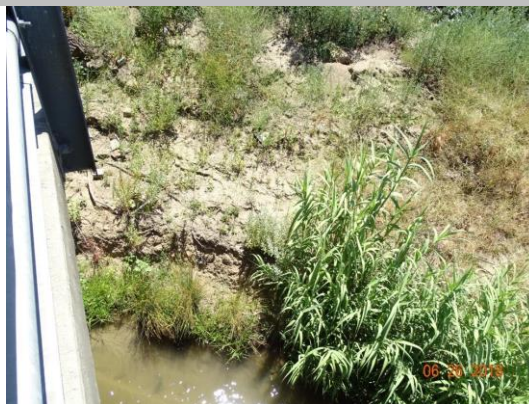
Photo 1 of 1 : CH\_2019\_NA0013\_33\_68\_20190722\_00045.jpg

Inspector Comments: There is minor erosion on the left bank.

Some erosion on left bank downstream of Oak Ave. crossing. Summer 2018

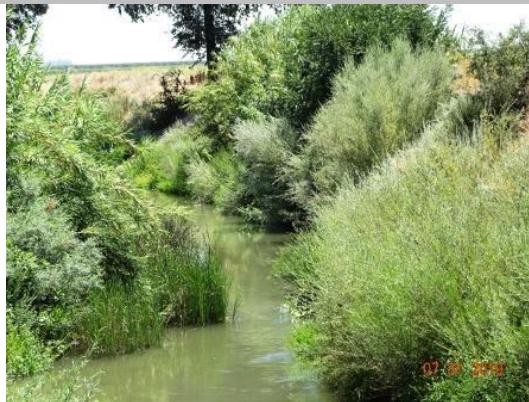
Photo 1 of 2 : CH\_2019\_NA0013\_33\_71\_20190809\_00075.jpg

Rating **	M	Issue No.	71	GPS Lat/Long
Issue Type +	Ma	Location *		37.268311 °
Category	Rivers, Channels & Designated Flood			-120.624111 °
Item	Vegetation & Obstructions			
DWR ID	DWR_NA0013_33_c_2016_71			
Action/Comments				
Inspector Comments: Remove Arundo from both banks.

View of Black Rascal Creek upstream of the Confluence with Bear Creek. Summer 2019

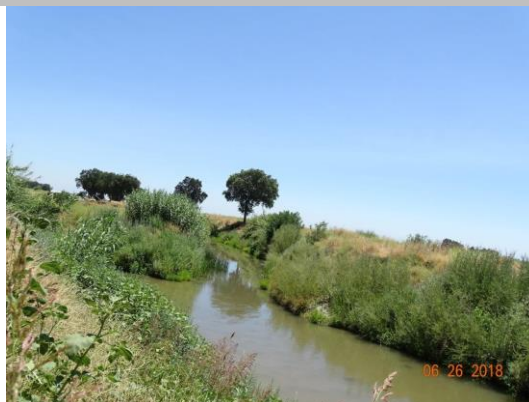
Photo 2 of 2 : CH\_2019\_NA0013\_33\_71\_20190722\_00046.jpg

Black Rascal Creek and the Confluence with Bear Creek. Summer 2018

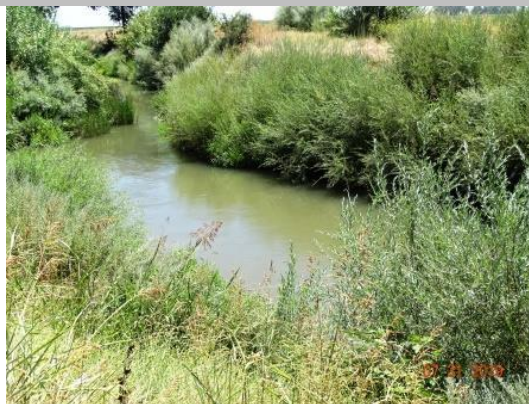
Photo 1 of 2 : CH\_2019\_NA0013\_33\_76\_20190809\_00076.jpg

View of the Bear Creek Confluence looking upstream. Summer 2019

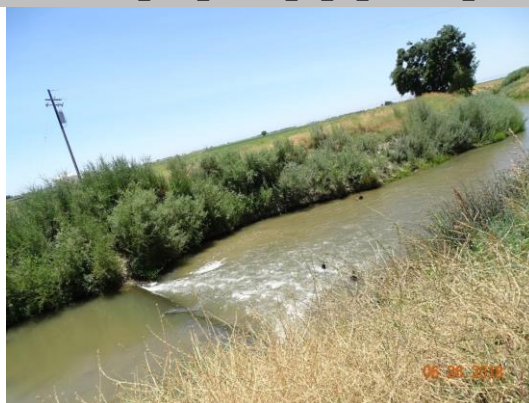
Photo 2 of 2 : CH\_2019\_NA0013\_33\_76\_20190722\_00048.jpg

View of vegetation looking downstream. Summer 2018

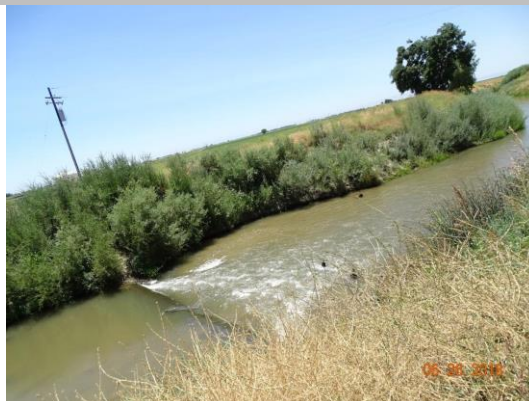
Photo 1 of 1 : CH\_2019\_NA0013\_33\_80\_20190722\_00050.jpg

Rating **	U	Issue No.	80	GPS Lat/Long
Issue Type +	En	Location *		37.268311 °
Category	Rivers, Channels & Designated Flood			-120.624111 °
Item	Encroachments			
DWR ID	DWR_NA0013_33_c_2016_80			
Action/Comments				
Inspector Comments: A concrete weir structure across the channel does not appear to have a permit.

View of weir structure across channel. Summer 2018

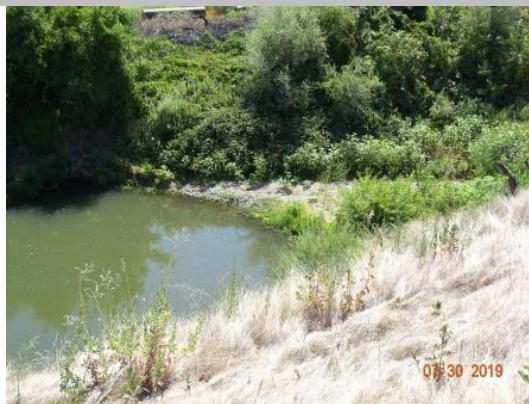
Photo 1 of 3 : CH\_2019\_NA0013\_34\_26\_20190807\_00022.jpg

Inspector Comments: This vantage point is on private property looking across the channel. The channel is not maintained, and overgrown brush along banks needs to be controlled or removed.

Downstream of the Confluence of the Burns and Bear Creeks viewed from private property on right bank. Summer 2019

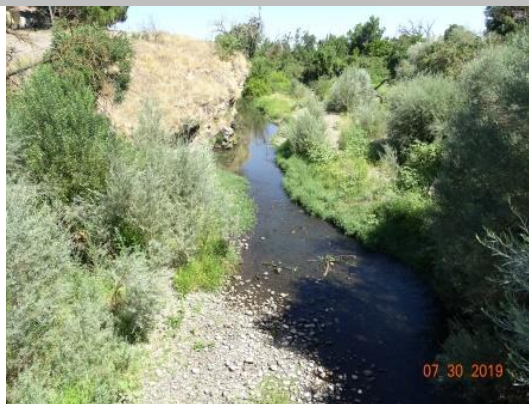
Photo 2 of 3 : CH\_2019\_NA0013\_34\_26\_20190807\_00023.jpg

View looking upstream at the Burns-Bear Creeks Confluence. Summer 2019

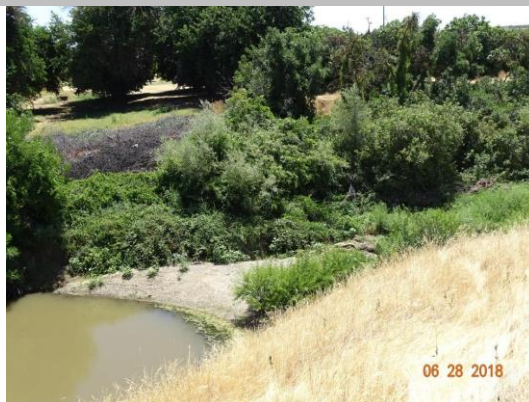
Photo 3 of 3 : CH\_2019\_NA0013\_34\_26\_20190722\_00008.jpg

Inspector Comments: This vantage point is on private property looking across the channel. The channel is not maintained, and overgrown brush along banks needs to be controlled or removed.

Downstream of the Confluence of the Burns and Bear Creeks viewed from private property on right bank. Summer 2018

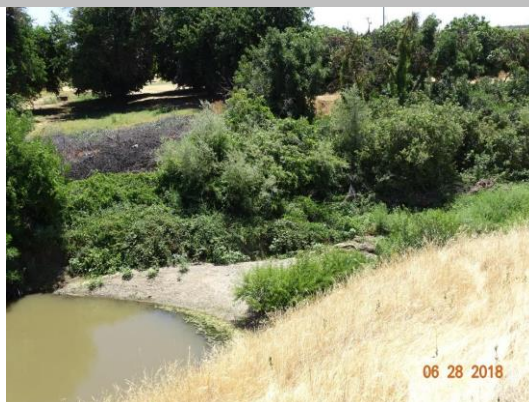
Photo 1 of 1 : CH\_2019\_NA0013\_34\_27\_20190722\_00010.jpg

Inspector Comments: The shoaling with established vegetation may impede flow and needs to be removed.

View of shoaling with established vegetation downstream of the confluence. Summer 2018

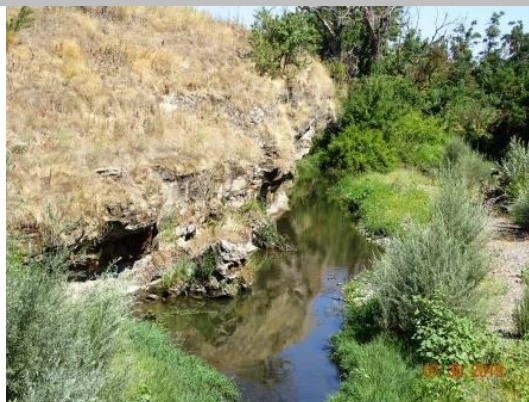
Photo 1 of 1 : CH\_2019\_NA0013\_34\_28\_20190807\_00024.jpg

Rating **	A	Issue No.	28	GPS Lat/Long
Issue Type +	Ma	Location *		37.333581 °
Category	Rivers, Channels & Designated Flood			-120.320642 °
Item	Erosion / Bank Caving			
DWR ID	DWR_NA0013_34_c_2016_28			
Action/Comments				
Inspector Comments: Rocky vertical bluff shows signs of historic erosion, but it does not appear to be active.

View looking at rocky vertical bluff on the right bank downstream of the Confluence. Summer 2019

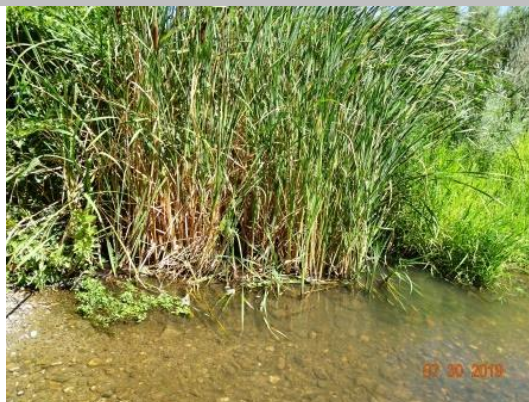
Photo 1 of 2 : CH\_2019\_NA0013\_34\_31\_20190808\_00027.jpg

Inspector Comments: Vegetation obstructs flow for the entire width of the creek.

View of vegetation across channel looking upstream from low water crossing. Summer 2019

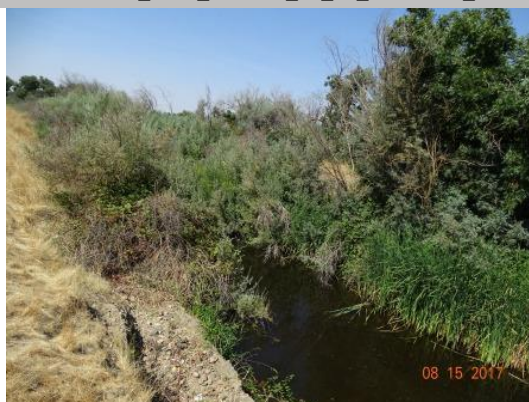
Photo 2 of 2 : CH\_2019\_NA0013\_34\_31\_20190722\_00011.jpg

Burns Creek looking upstream from the low water crossing. 2017

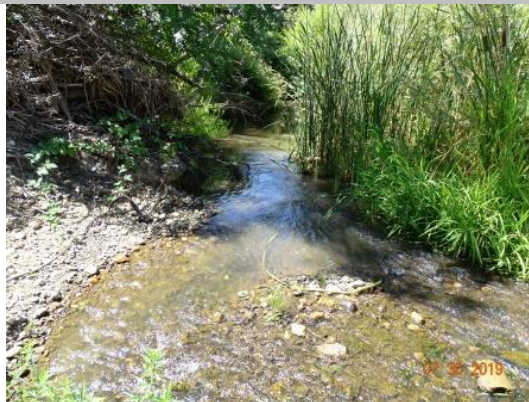
Photo 1 of 2 : CH\_2019\_NA0013\_34\_37\_20190808\_00029.jpg

Inspector Comments: The channel is completely overgrown and has never been maintained. Access to this location requires notification to property owner.

View looking downstream from low water crossing. Summer 2019

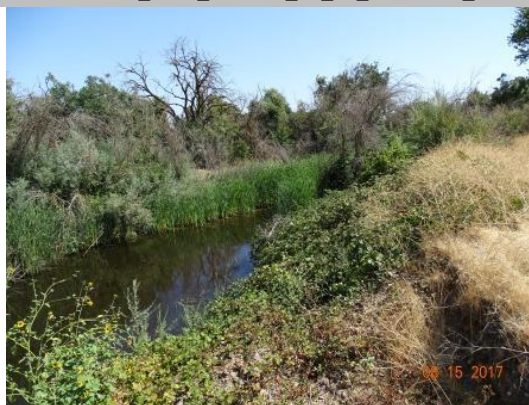
Photo 2 of 2 : CH\_2019\_NA0013\_34\_37\_20190722\_00012.jpg

View of Burns Creek from the low water crossing.

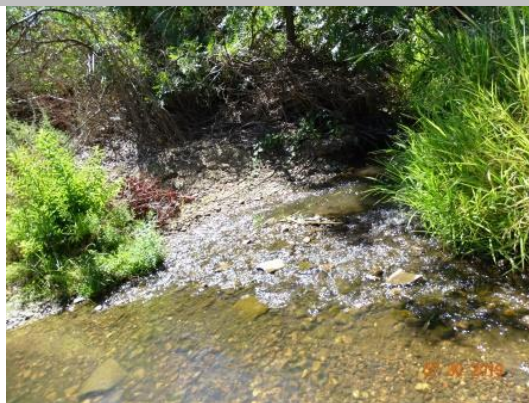
Photo 1 of 1 : CH\_2019\_NA0013\_34\_38\_20190808\_00030.jpg

Inspector Comments: Sedimentation is redirecting the flows that have eroded the left bank.

View looking downstream at erosion on the left bank. Summer 2019

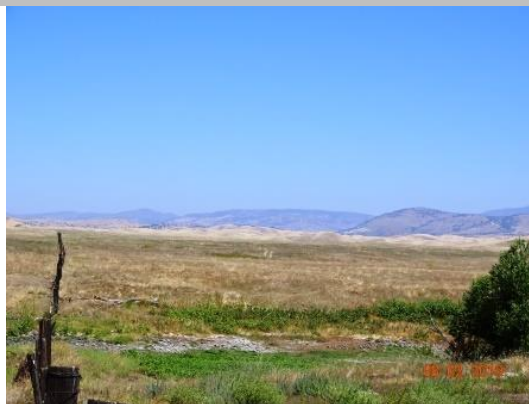
Photo 1 of 2 : CH\_2019\_NA0013\_35\_1\_20190814\_00134.jpg

View of vegetation in the channel. Summer 2019

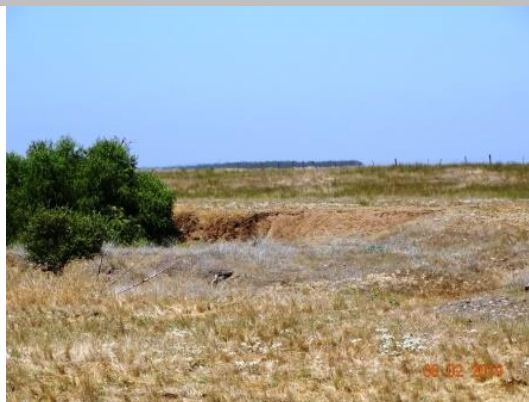
Photo 1 of 2 : CH\_2019\_NA0013\_35\_6\_20190814\_00135.jpg

View of vegetation in the channel. Summer 2019

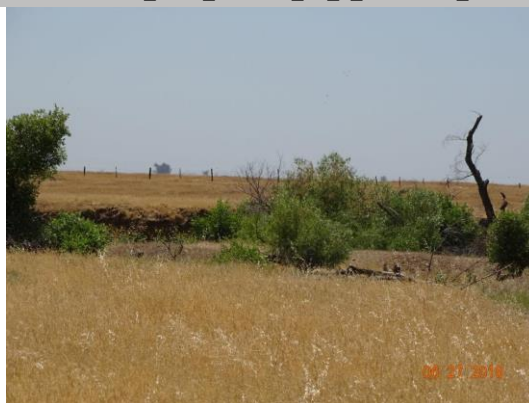
Photo 2 of 2 : CH\_2019\_NA0013\_35\_6\_20190722\_00003.jpg

View of vegetation in channel. Summer 2018

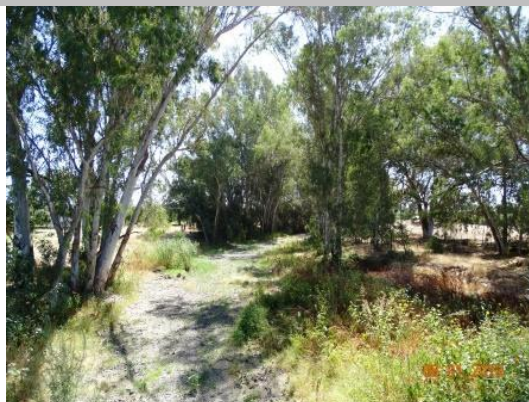
Photo 1 of 2 : CH\_2019\_NA0013\_35\_11\_20190809\_00105.jpg

View of vegetation in the channel. Summer 2019

Inspector Comments: Remove Arundo from the left bank.

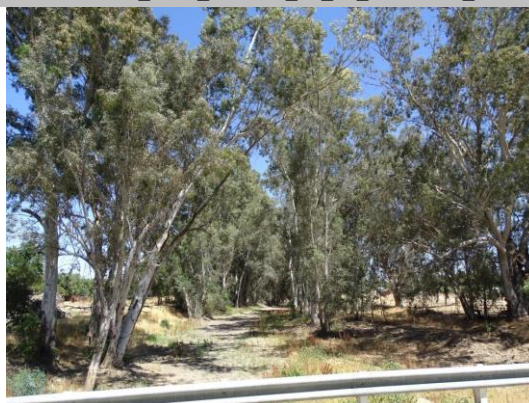
Photo 2 of 2 : CH\_2019\_NA0013\_35\_11\_20190722\_00005.jpg

View of vegetation in channel. Summer 2018
